**Flood Control Project Maintenance  
Levee Inspections**

**Fall 2018 Levee Maintenance Deficiency Summary Report**

**Sacramento River Basin**

**Reclamation District No. 1500 Sutter Basin**

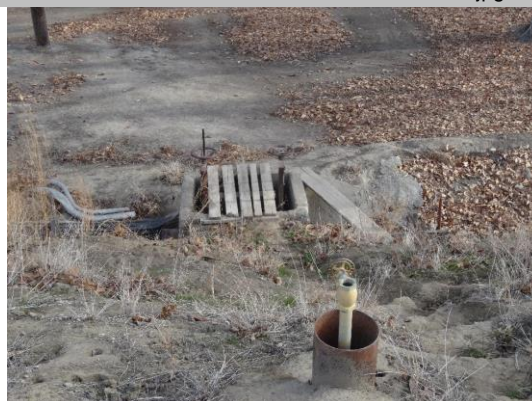
Photo 2 of 3 : UCIP\_FA\_2018\_28183\_51844.jpg

LM Start	<b>0.31</b>	Rating **	M	Issue No.	<b>2550 (cont)</b>
LM End	<b>0.31</b>	Issue Type +	En	Location *

LS view: pressure breaker (bottom) in steel pipe riser and concrete distribution box on levee toe.

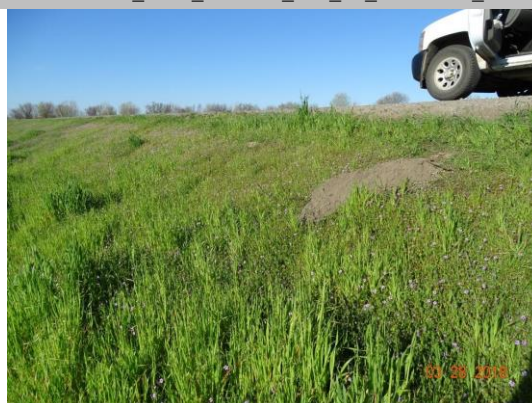
Photo 1 of 2 : FA\_2018\_RD1500\_189\_99\_20180904\_00039.jpg

LM Start	1.25	Rating **	M	Issue No.	99
LM End	1.25	Issue Type +	Ma	Location *	LS
Category	Earthen Levee			GPS Latitude/Longitude	
				Start	End
Item	Animal Control			38.769274 °	38.769274 °
				-121.691700 °	-121.691700 °
DWR ID	DWR_RD1500_01_f_2017_99				
Comment Code					
A3 : No rodents visible, but rodent burrows visible; need to backfill and compact or grout burrows.					
Inspector Comment					
Multiple rodent holes and mounds on landside slope.

Updated view of rodent holes. Spring 2018

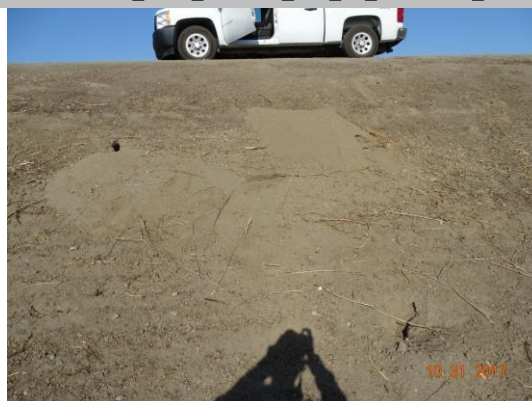
Photo 2 of 2 : FA\_2018\_RD1500\_189\_99\_20180904\_00040.jpg

View of holes and mounds on landside slope. Fall 2017.

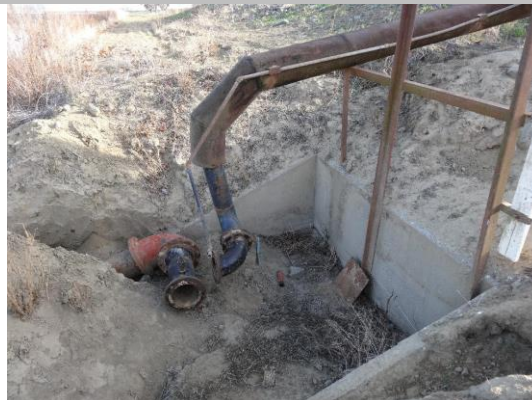
Photo 2 of 3 : UCIP\_FA\_2018\_28903\_53161.jpg

Comment Code						
Inspector Comment						
FS_ID:28903 DS_ID:20094 EP_NO: 10080 Repair Type: Non-Urgent Crossing Status: Found UCIP Comments: Pump removed from concrete pad and kept inside pump house (may be for storage purpose) on waterside.A 8-inch steel pipe inside 14-inch pipe. FIELD_STRUCT_DESC: 1 of 2: 14-inch steel irrigation discharge pipe through the levee, 5.2 feet below the crown. Pump in a corrugated metal pump house on the waterside (WS) slope. Butterfly valve on the WS. Concrete staircase on the WS slope. 1.75-inch galvanized iron water line with faucet exposed on the landside (LS) slope, 3.4 feet below the crown. 4-foot by 5.7-foot concrete distribution box at the LS toe. 1.25-inch conduit through levee, 2 feet below the crown. (14-inch steel irrigation discharge pipe through the levee and pump in a corrugated metal pump house on the WS slope authorized under Automatic Board Order (ABO) issued as Permit No. 10080, 1974 - Sebastian Yturralde). [Additional Reference(s): DWR Levee Log, 2005. USACE Sacramento O&M Manual 128, March 1960, (HLM 1.28)]. FS Date: 1/9/2014

WS view: U type headwall and 8-inch pipe sleeved into 14-inch steel pipe. Pump was removed from the pipe.

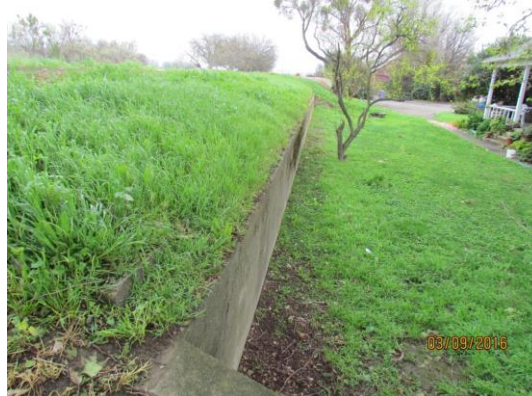
Photo 1 of 1 : FA\_2018\_RD1500\_189\_4\_20180904\_00001.jpg

LM Start	1.33	Rating **	M	Issue No.	4
LM End	1.33	Issue Type +	En	Location *	LS
Category	Earthen Levee			GPS Latitude/Longitude	
				Start	End
Item	Encroachments			38.770023 °	38.770023 °
				-121.690575 °	-121.690575 °
DWR ID	DWR_RD1500_01_s_2012_4				
Comment Code					
RW : Retaining Wall					
Inspector Comment					
Retaining wall built into the levee.

View of the retaining wall that is in USACE as-builts on the landward side of the levee looking upstream. Wall cuts into levee toe. Spring 2016.

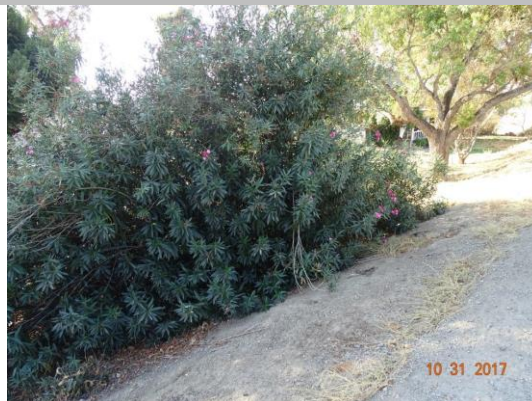
Photo 1 of 1 : FA\_2018\_RD1500\_189\_98\_20180904\_00038.jpg

Oleander bush partially blocking the landside slope.

View of vegetation on landside slope. Fall 2017.

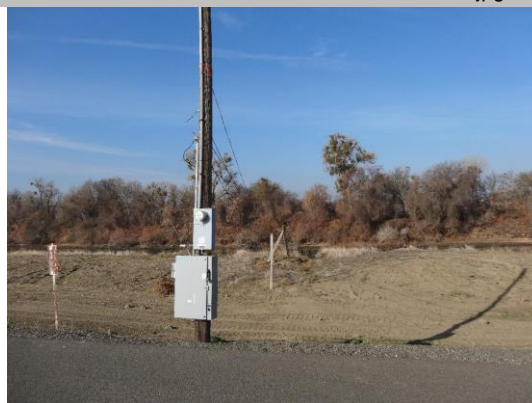
Photo 1 of 3 : UCIP\_FA\_2018\_28204\_51875.jpg

Comment Code						
Inspector Comment						
FS_ID:28204 DS_ID:20033 EP_NO: N/A Repair Type: Non-Urgent Crossing Status: Found UCIP Comments: - pump removed- erosion around pump station.- overhead electrical line. FIELD_STRUCT_DESC: 10-inch steel irrigation discharge pipe through the levee, 10 feet below the crown. Pump and gate valve on the riverbank. Service pole and switch panel on the waterside (WS) shoulder. Pipe crosses irrigation ditch and discharges into a steel distribution box in the field. (10-inch steel irrigation discharge pipe through the levee and pump on the riverbank authorized under Automatic Board Order (ABO) issued as Permit No. 10043, 1974 - Leo Giovanetti). [Additional Reference(s): DWR Levee Log, 2005. USACE Sacramento O&M Manual 128, March 1960, (HLM 1.63)]. FS Date: 1/9/2014

WS view: Service pole with control panel on levee shoulder.

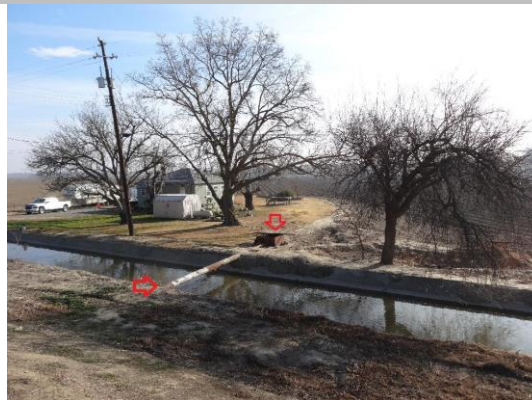
Photo 3 of 3 : UCIP\_FA\_2018\_28204\_51873.jpg

LS view: pipe crosses irrigation ditch. Steel distribution box across irrigation ditch.

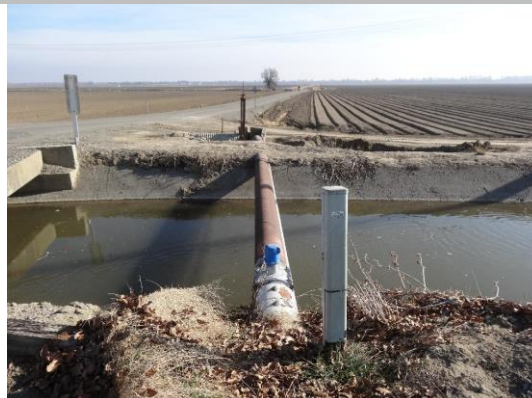
Photo 3 of 3 : UCIP\_FA\_2018\_28263\_51963.jpg

Comment Code						
Inspector Comment						
FS_ID:28263 DS_ID:20034 EP_NO: 16146 Repair Type: Non-Urgent Crossing Status: Found UCIP Comments: - pump removed- overhead powerline- pile structure abandoned- levee slope erosion due to leaky siphon breaker on landside. FIELD_STRUCT_DESC: *REPLACEMENT CROSSING* 12-inch steel irrigation discharge pipe through the levee, 12 feet below the crown. Pump mounted on the riverbank. Butterfly valve on the waterside (WS). Power pole with one anchor on the WS slope. Pipe discharges into a 5-foot by 5-foot damaged concrete distribution box across the irrigation ditch on the landside (LS). Electrical conduit through the levee. (Cat. I - Furlan). (Abandonment-in-place of an existing pipe and replacement of approximately 70 feet of 12-inch irrigation discharge pipe authorized under Permit No. 16146, 1993 - Antonio Furlan and Joe Schreiner). [Additional Reference(s): DWR Levee Log, 2005. USACE Sacramento O&M Manual 128, March 1960, (HLM 1.96)]. FS Date: 1/9/2014

LS view: discharge pipe crossing irrigation ditch.

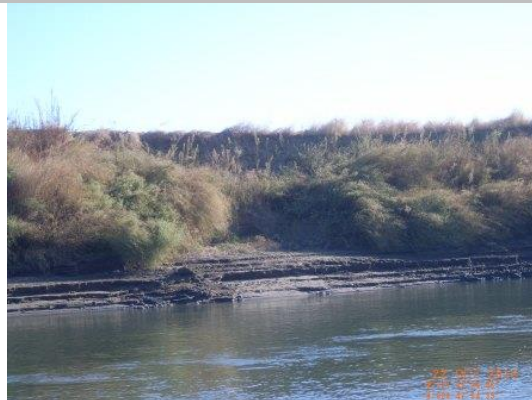
Photo 1 of 1 : FA\_2018\_RD1500\_189\_87\_20181023\_00238.jpg

LM Start	2.30	Rating **	A/W	Issue No.	87	
LM End	2.52	Issue Type +	Ma	Location *	WS	
Category	Supplemental			GPS Latitude/Longitude		
				Start	End	
Item	2017 USACE Erosion Survey, DRAFT			38.781962 °	38.784936 °	
				-121.688033 °	-121.690033 °	
DWR ID	DWR_RD1500_01_f_2018_87					
Comment Code						
Inspector Comment						
2017 Site ID: SAC 87.1 L						
Status: Eroding						
2017 Field Notes: Large whole bank failure section in middle of site.						
Site History: 2010 - The upstream end of the repair site at 87.0. Repair did not extend far enough upstream. 2011 - New erosion pockets.						
2012 - Minor new erosion at toe. 2013 - Minor new erosion. 2015 - Significant new toe erosion. 2016 - Fresh erosion on riverbank.

USACE 2013 Photo #1

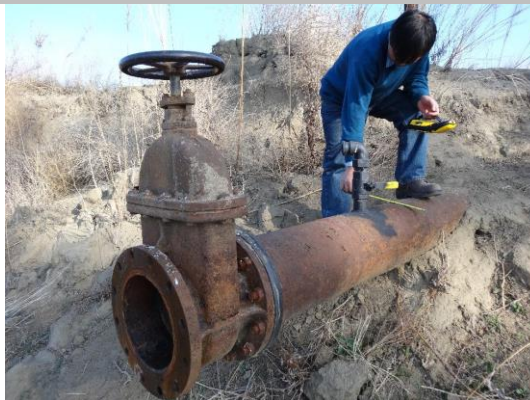
Photo 1 of 3 : UCIP\_FA\_2018\_28264\_51971.jpg

Comment Code						
Inspector Comment						
FS_ID:28264 DS_ID:20035 EP_NO: 10029 Repair Type: Non-Urgent Crossing Status: Found UCIP Comments: - pump removed- outlet plugged- looks abandoned. Found abandoned pipe parts on levee slope and berm.- overhead powerline FIELD_STRUCT_DESC: *ABANDONED* 12-inch steel irrigation discharge pipe through the levee, 11 feet below the crown. Two metal cutoff walls installed. Pumps on the riverbank during irrigation season. Gate valve at the waterside (WS) toe. Pipe discharges into a 2.5-foot by 2.5-foot concrete distribution box on the landside (LS) of the irrigation ditch. (Retention of a 12-inch steel irrigation discharge pipe through the levee and pumps on the riverbank during irrigation season authorized under Automatic Board Order (ABO) issued as Permit No. 10029, 1974 - Merle Anderson). [Additional Reference(s): DWR Levee Log, 2005. USACE Sacramento O&M Manual 128, March 1960, (HLM 2.40)]. FS Date: 1/9/2014

WS view: steel pipe, gate valve, and pump (removed) on river bank. Looks abandoned.

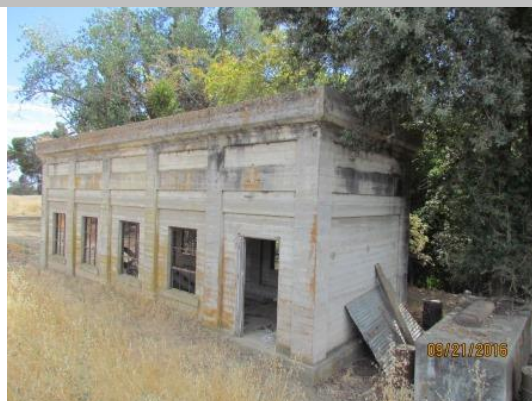
Photo 1 of 1 : FA\_2018\_RD1500\_189\_131\_20180904\_00064.jpg

LM Start	3.69	Rating **	M	Issue No.	131
LM End	3.69	Issue Type +	En	Location *	WS
Category	Earthen Levee			GPS Latitude/Longitude	
				Start	End
Item	Encroachments			38.797152 °	38.797152 °
				-121.691238 °	-121.691238 °
DWR ID	DWR_RD1500_01_f_2016_131				
Comment Code					
BU : Building					
Inspector Comment					
Abandoned building

Abandoned building at waterward toe of the levee. Fall 2016.

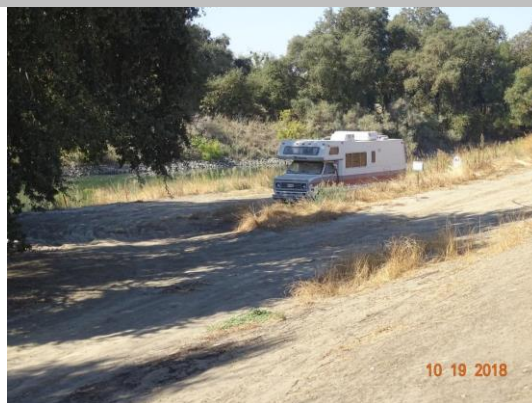
Photo 1 of 1 : FA\_2018\_RD1500\_189\_128\_20181018\_00237.jpg

LM Start	3.94	Rating **	U	Issue No.	128
LM End	3.94	Issue Type +	En	Location *	WS
Category	Earthen Levee			GPS Latitude/Longitude	
				Start	End
Item	Encroachments			38.797541 °	38.797541 °
				-121.695674 °	-121.695674 °
DWR ID	DWR_RD1500_01_s_2018_128				
Comment Code					
UR : Urban					
Inspector Comment					
Mobile trailer on the waterside berm taking up long-term residence.

View of the trailer on the waterside berm. Fall 2018.

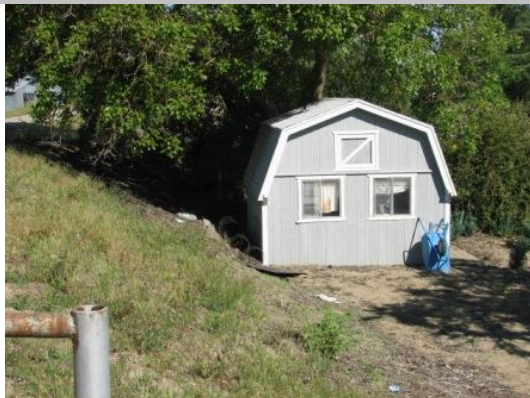
Photo 1 of 2 : FA\_2018\_RD1500\_189\_7\_20180904\_00002.jpg

LM Start	3.94	Rating **	U	Issue No.	7
LM End	3.94	Issue Type +	En	Location *	LS
Category	Earthen Levee			GPS Latitude/Longitude	
				Start	End
Item	Encroachments			38.797573 °	38.797573 °
				-121.695727 °	-121.695727 °
DWR ID	DWR_RD1500_01_s_2012_7				
Comment Code					
BU : Building					
Inspector Comment

A small building is encroaching into the landside levee toe.

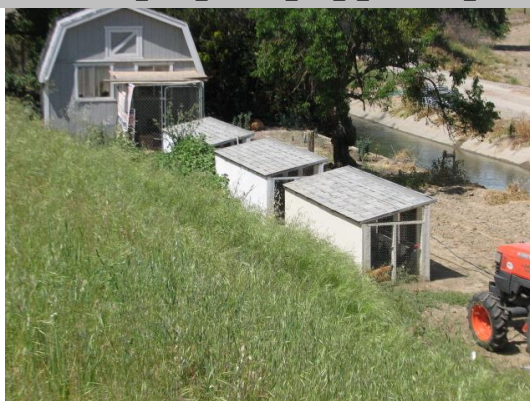
Photo 2 of 2 : FA\_2018\_RD1500\_189\_7\_20180904\_00003.jpg

Chicken coupes have been added along the toe of the levee. Spring

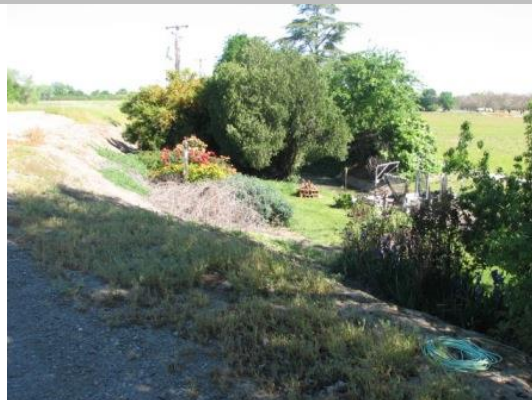
Photo 1 of 2 : FA\_2018\_RD1500\_189\_8\_20180904\_00004.jpg

LM Start	3.97	Rating **	A/W	Issue No.	8
LM End	3.97	Issue Type +	En	Location *	LS
Category	Earthen Levee			GPS Latitude/Longitude	
				Start	End
Item	Vegetation			38.797838 °	38.797838 °
				-121.696046 °	-121.696046 °
DWR ID	DWR_RD1500_01_s_2012_8				
Comment Code					
V6 : Landscaping					
Inspector Comment					
Most of the vegetation has been removed. There appears to be new landscaping at the toe of the levee.

The landscape is planted into the encroachment zone within 15' of the toe.

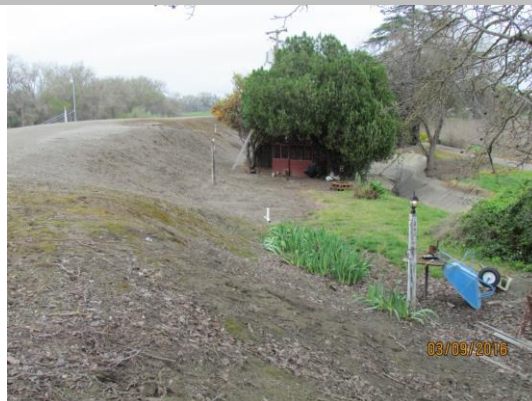
Photo 2 of 2 : FA\_2018\_RD1500\_189\_8\_20180904\_00005.jpg

View of the landscaping on the landward side of the levee looking upstream. Spring 2016.

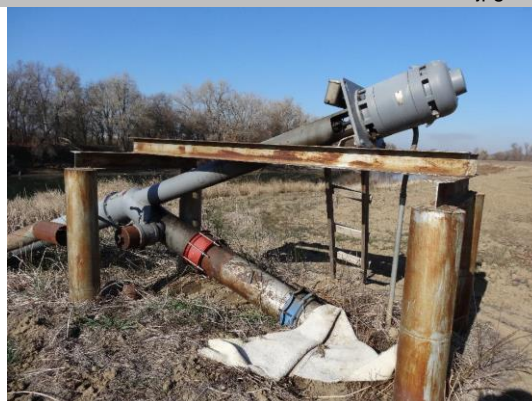
Photo 1 of 3 : UCIP\_FA\_2018\_28272\_52012.jpg

Comment Code						
Inspector Comment						
FS_ID:28272						
DS_ID:20037						
EP_NO: 3638						
Repair Type: Non-Urgent						
Crossing Status: Found						
UCIP Comments: - No protection for pressure breaker.						
FIELD_STRUCT_DESC: 12-inch steel irrigation discharge pipe through the levee, 2.4 feet below the crown. Slant pump on the berm. Siphon breaker on the landside (LS) slope. Service pole at the LS toe. Pipe discharges into a 36-inch concrete standpipe on the LS. (Installation, maintenance, and operation of an inclined pump and an existing pipe to remain through the levee authorized under Permit No. 3638, 1961 - James F. Waters). [Additional Reference(s): DWR Levee Log, 2005. USACE Sacramento O&M Manual 128, March 1960, (HLM 4.04)].						
FS Date: 1/9/2014

WS view: slant pump on steel frame on levee berm.

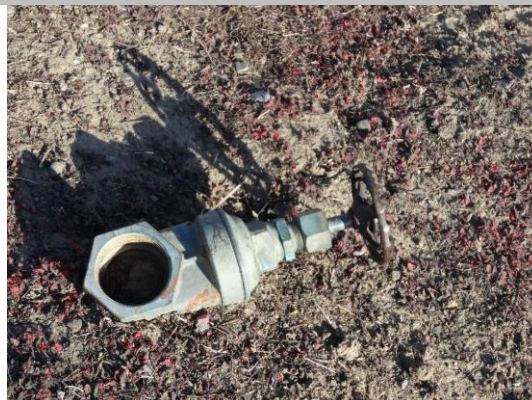
Photo 2 of 3 : UCIP\_FA\_2018\_28272\_52011.jpg

LS view: pressure breaker without protection on levee slope.

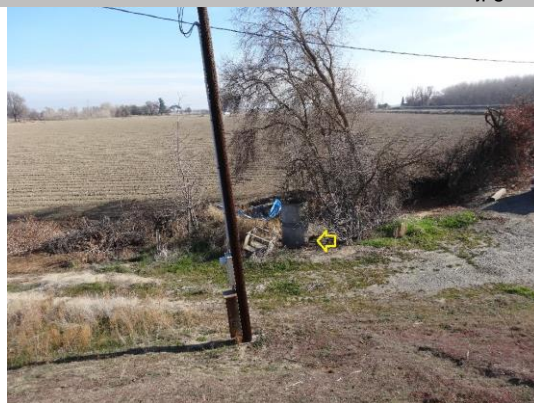
Photo 3 of 3 : UCIP\_FA\_2018\_28272\_52013.jpg

LS view: power pole and concrete standpipe on levee toe.

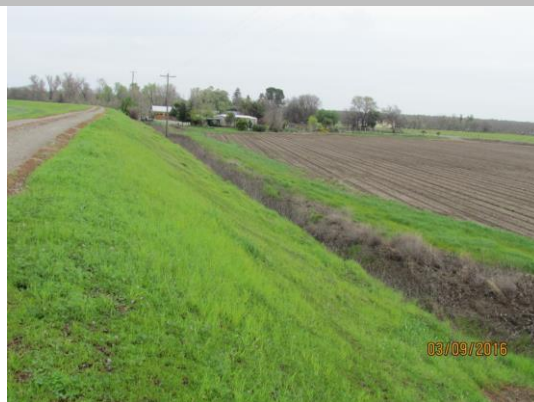
Photo 1 of 1 : FA\_2018\_RD1500\_189\_54\_20180904\_00026.jpg

LM Start	4.02	Rating **	M	Issue No.	54
LM End	4.12	Issue Type +	En	Location *	LS
Category	Earthen Levee			GPS Latitude/Longitude	
				Start	End
Item	Encroachments			38.798526 °	38.800063 °
				-121.696326 °	-121.696622 °
DWR ID	DWR_RD1500_01_s_2012_54				
Comment Code					
DT : Ditch					
Inspector Comment					
Ditch runs along the toe of the levee.

View of the ditch on the landward side of the levee looking upstream. Spring 2016.

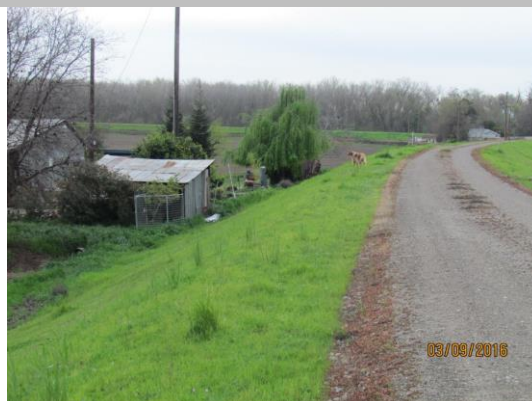
Photo 1 of 1 : FA\_2018\_RD1500\_189\_11\_20180904\_00006.jpg

LM Start	4.16	Rating **	M	Issue No.	11
LM End	4.16	Issue Type +	En	Location *	LS
Category	Earthen Levee			GPS Latitude/Longitude	
				Start	End
Item	Encroachments			38.800548 °	38.800548 °
				-121.696751 °	-121.696751 °
DWR ID	DWR_RD1500_01_s_2012_11				
Comment Code					
BU : Building					
Inspector Comment

View of the equipment shed on the landward side of the levee looking downstream. Spring 2016.

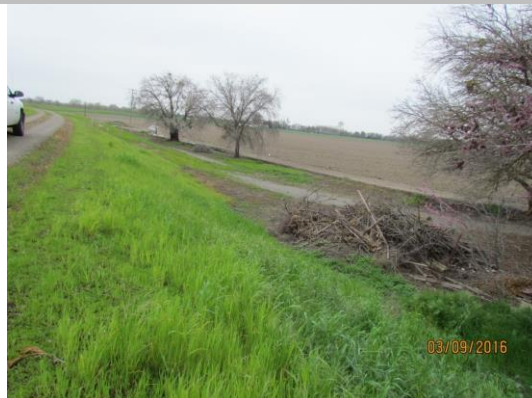
Photo 1 of 1 : FA\_2018\_RD1500\_189\_142\_20180904\_00070.jpg

LM Start	4.61	Rating **	M	Issue No.	142
LM End	4.61	Issue Type +	En	Location *	LS
Category	Earthen Levee			GPS Latitude/Longitude	
				Start	End
Item	Encroachments			38.803509 °	38.803509 °
				-121.703046 °	-121.703046 °
DWR ID	DWR_RD1500_01_f_2018_142				
Comment Code					
PR : Prunings					
Inspector Comment

View of the pruning pile on the landward side of the levee looking upstream. Spring 2016.

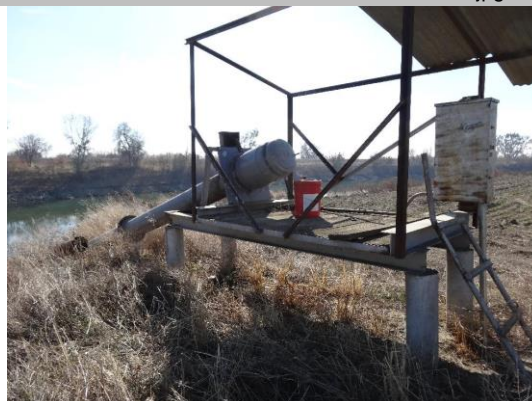
Photo 1 of 3 : UCIP\_FA\_2018\_28912\_53181.jpg

Comment Code						
Inspector Comment						
FS_ID:28912 DS_ID:20040 EP_NO: 5031 Repair Type: Non-Urgent Crossing Status: Found UCIP Comments: New butterfly valve in CMP riser on waterside slope. New pipe and pump.Needs cleaning and clearing of siphon breaker in CMP on landside.An abandoned 5x5 foot concrete distribution box on landside. Abandoned pipe found on both sides of the levee. FIELD_STRUCT_DESC: 12-inch steel irrigation discharge pipe through the levee at a slight angle, 4.2 feet below the crown. 2-inch conduit through the levee, 2 feet below the crown. Slant pump on a steel platform on the berm. (Slant pump authorized under Permit No. 5031, 1965 - Gladys Johnston and Helen Dixon). Pipe discharges into an irrigation ditch and an abandoned 5-foot by 5-foot concrete distribution box on the landside. (Pipe originally installed in 1950. 12-inch centrifugal irrigation pump and 14-inch, 12-gage welded steel pipe through the levee authorized under Permit No. 1466, 1950 - Estate of Caroline L. Knox. Pipe reinstalled by USACE in 1958). [Additional Reference(s): DWR Levee Log, 2005. USACE Sacramento O&M Manual 128, March 1960, (HLM 4.71)]. FS Date: 1/9/2014

WS view: slant pump and switch panel in shed on levee berm.

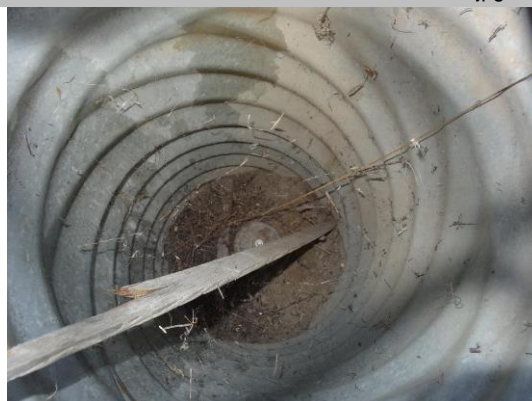
Photo 2 of 3 : UCIP\_FA\_2018\_28912\_53180.jpg

Comment Code						
Inspector Comment						
FS_ID:28912 DS_ID:20040 EP_NO: 5031 Repair Type: Non-Urgent Crossing Status: Found UCIP Comments: New butterfly valve in CMP riser on waterside slope. New pipe and pump.Needs cleaning and clearing of siphon breaker in CMP on landside.An abandoned 5x5 foot concrete distribution box on landside. Abandoned pipe found on both sides of the levee. FIELD_STRUCT_DESC: 12-inch steel irrigation discharge pipe through the levee at a slight angle, 4.2 feet below the crown. 2-inch conduit through the levee, 2 feet below the crown. Slant pump on a steel platform on the berm. (Slant pump authorized under Permit No. 5031, 1965 - Gladys Johnston and Helen Dixon). Pipe discharges into an irrigation ditch and an abandoned 5-foot by 5-foot concrete distribution box on the landside. (Pipe originally installed in 1950. 12-inch centrifugal irrigation pump and 14-inch, 12-gage welded steel pipe through the levee authorized under Permit No. 1466, 1950 - Estate of Caroline L. Knox. Pipe reinstalled by USACE in 1958). [Additional Reference(s): DWR Levee Log, 2005. USACE Sacramento O&M Manual 128, March 1960, (HLM 4.71)]. FS Date: 1/9/2014

LS view: obstructed siphon breaker in CMP riser.

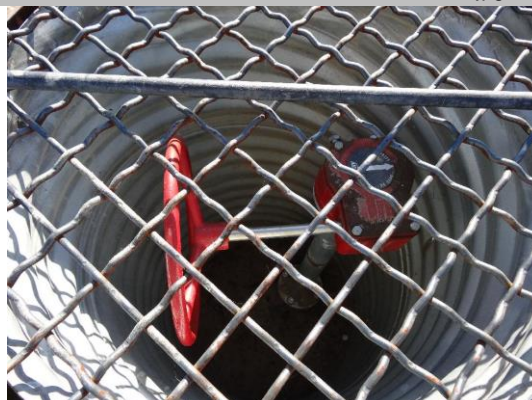
Photo 3 of 3 : UCIP\_FA\_2018\_28912\_53179.jpg

WS view: new butterfly valve in CMP on levee shoulder.

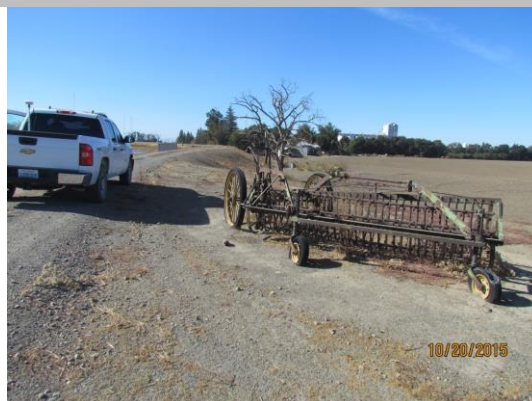
Photo 1 of 1 : FA\_2018\_RD1500\_189\_108\_20180904\_00045.jpg

LM Start	5.14	Rating **	M	Issue No.	108
LM End	5.14	Issue Type +	En	Location *	LS
Category	Earthen Levee			GPS Latitude/Longitude	
				Start	End
Item	Encroachments			38.801962 °	38.801962 °
				-121.712118 °	-121.712118 °
DWR ID	DWR_RD1500_01_f_2015_108				
Comment Code					
EQ : Equipment					
Inspector Comment

View of the equipment on the landward side of the levee looking upstream. Fall 2015.

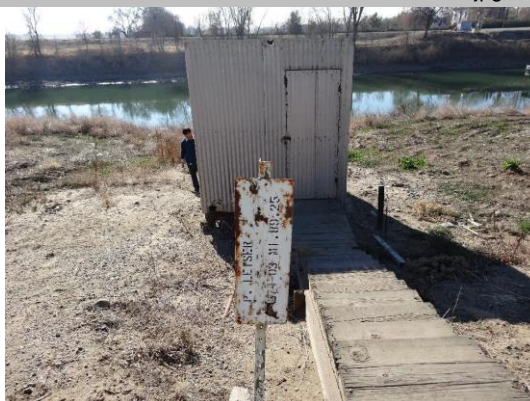
Photo 1 of 3 : UCIP\_FA\_2018\_28913\_53184.jpg

WS view: wooden steps to pump house on levee berm.

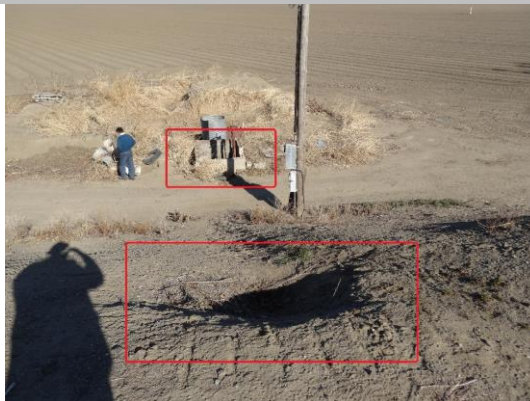
Photo 2 of 3 : UCIP\_FA\_2018\_28913\_53183.jpg

Comment Code						
Inspector Comment						
FS_ID:28913 DS_ID:20041 EP_NO: 10056 Repair Type: Non-Urgent Crossing Status: Found UCIP Comments: Depression on landside levee slope around siphon breaker due to leakage.Siphon breaker needs protection. FIELD_STRUCT_DESC: 18-inch steel irrigation discharge pipe through the levee, 4 feet below the crown. 1.5-inch conduit through the levee, 20 feet below the crown. Slant pump in a corrugated metal pump house on the waterside (WS). Wooden steps on the WS slope. Siphon breaker on the landside (LS) slope. 5-foot by 5-foot concrete distribution box at the LS toe. (18-inch steel irrigation discharge pipe and all other elements of this irrigation structure retained under Automatic Board Order (ABO) issued as Permit No. 10056, 1974 - Philip Leiser). [Additional Reference(s): DWR Levee Log, 2005. USACE Sacramento O&M Manual 128, March 1960, (HLM 5.23)]. FS Date: 1/9/2014

LS view: depression on landside levee slope around siphon breaker due to leakage. Concrete distribution box (top) on levee toe.

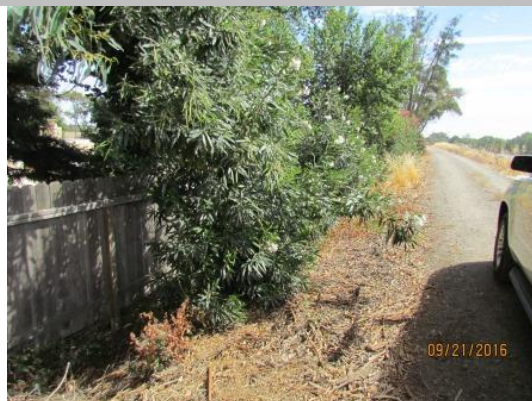
Photo 1 of 1 : FA\_2018\_RD1500\_189\_125\_20180904\_00062.jpg

LM Start	5.32	Rating **	U	Issue No.	125
LM End	5.35	Issue Type +	En	Location *	LS
Category	Earthen Levee			GPS Latitude/Longitude	
				Start	End
Item	Encroachments			38.803181°	38.803344°
				-121.715141°	-121.715616°
DWR ID	DWR_RD1500_01_f_2016_125				
Comment Code					
FE : Fence					
Inspector Comment

View of fence and vegetation on LS slope. Fall 2016.

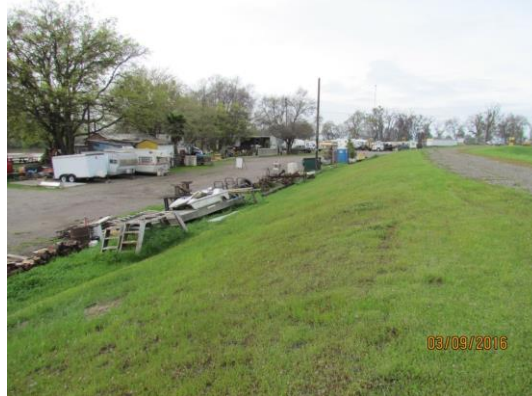
Photo 1 of 1 : FA\_2018\_RD1500\_189\_52\_20180904\_00025.jpg

LM Start	5.61	Rating **	M	Issue No.	52
LM End	5.69	Issue Type +	En	Location *	WS
Category	Earthen Levee			GPS Latitude/Longitude	
				Start	End
Item	Encroachments			38.803067 °	38.803238 °
				-121.720270 °	-121.721847 °
DWR ID	DWR_RD1500_01_s_2012_52				
Comment Code					
EQ : Equipment					
Inspector Comment					
Sting Rayz Beach Boardwalk Marina on the waterside berm should move equipment stored on levee toe away from levee.

View of equipment on waterside levee toe looking upstream. Spring 2016.

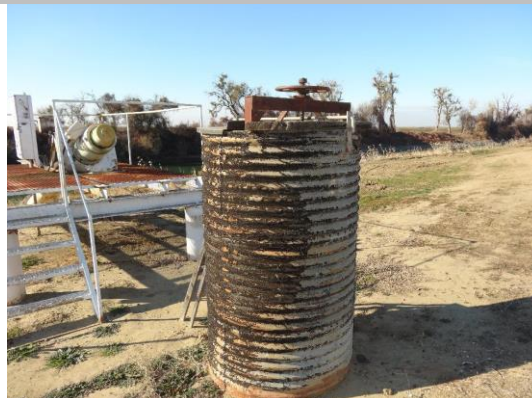
Photo 1 of 2 : UCIP\_FA\_2018\_28286\_52059.jpg

WS view: CMP riser with slide gate and slant pump on steel platform on levee berm.

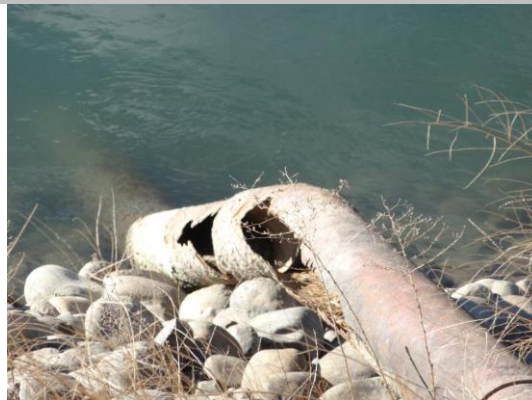
Photo 2 of 3 : UCIP\_FA\_2018\_28923\_53201.jpg

Comment Code						
Inspector Comment						
FS_ID:28923 DS_ID:20047 EP_NO: 10048 Repair Type: Non-Urgent Crossing Status: Found UCIP Comments: An abandoned pipe. Highly deteriorated pipe on river bank.Needs proper abandonment.Not found- Siphon breaker at landward levee toe. FIELD_STRUCT_DESC: *ABANDONED* 10-inch steel irrigation discharge pipe and a 1-inch conduit through the levee, 4.5 feet below the crown. Pump in a metal shed on the riverbank. Gate valve on the waterside (WS) end. Service pole and 24-inch concrete standpipe at the landside (LS) toe. Installed by USACE in 1958. (10-inch steel irrigation discharge pipe through the levee and all other appurtenances retained under Automatic Board Order (ABO) issued as Permit No. 10048, 1974 - Virgil J. King) [Additional Reference(s): DWR Levee Log, 2005. USACE Sacramento O&M Manual 128, March 1960, (HLM 7.22)]. FS Date: 1/9/2014

WS view: deteriorated and abandoned steel pipe on river bank.

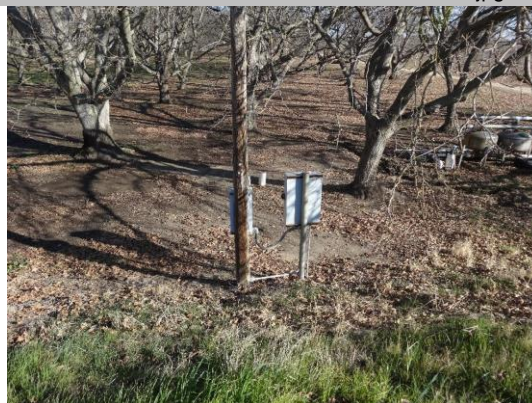
Photo 3 of 3 : UCIP\_FA\_2018\_28923\_53200.jpg

LS view: service pole and switch board on levee toe. No other appurtenances found on landside.

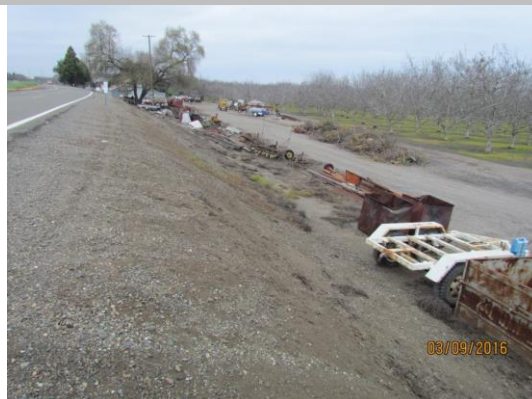
Photo 1 of 1 : FA\_2018\_RD1500\_189\_16\_20180904\_00007.jpg

LM Start	7.49	Rating **	M	Issue No.	16
LM End	7.49	Issue Type +	En	Location *	LS
Category	Earthen Levee			GPS Latitude/Longitude	
				Start	End
Item	Encroachments			38.828944 °	38.828944 °
				-121.724329 °	-121.724329 °
DWR ID	DWR_RD1500_01_f_2017_16				
Comment Code					
EQ : Equipment					
Inspector Comment

View of the equipment along the levee toe on the landward side of the levee looking upstream. Spring 2016.

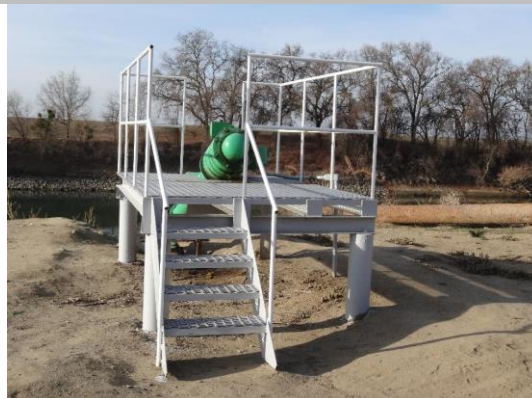
Photo 1 of 3 : UCIP\_FA\_2018\_50199\_53204.jpg

WS view: slant pump on steel platform on end of berm.

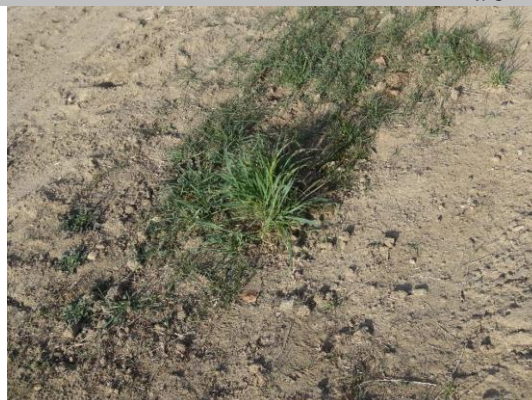
Photo 2 of 3 : UCIP\_FA\_2018\_50199\_53203.jpg

Comment Code					
Inspector Comment					
FS_ID:50199 DS_ID:20049 EP_NO: 8147 Repair Type: Non-Urgent Crossing Status: Found UCIP Comments: 08/29/2016: New pumps installed at LS toe ditch, could not find permit for this work. No signs of leakage or excessive vegetation growth in alignment with the pipe. Riser silted in; recommend installing a lid. Crossing has been downgraded from Urgent to Non-Urgent. (K. Fazel - UCIP)01/10/2014:Not found- slide gate in 48-inch corrugated metal riser at waterside toe.Repair works under way. Contact LMA for repair works information.Sign of leaky pipe and siphon breaker. This needs detailed investigation. (P. Amatya - DWR) FIELD_STRUCT_DESC: 12-inch steel irrigation discharge pipe through the levee, 4.8 feet below the crown. Slant pump mounted on a steel structure at the riverbank. 4-foot by 4-foot concrete distribution box at the landside (LS) toe with newly installed pumps with shutoff valves. (Replacement of a discharge pipe through the levee with a new 12-inch steel discharge pipe authorized under Permit No. 8147, 1972 - J. A. Driver). [Additional Reference(s): DWR Levee Log, 2005. USACE Sacramento O&M Manual 128, March 1960, (HLM 7.79)]. FS Date: 8/29/2016

WS view: sign of leakage- excessive vegetation on levee slope.

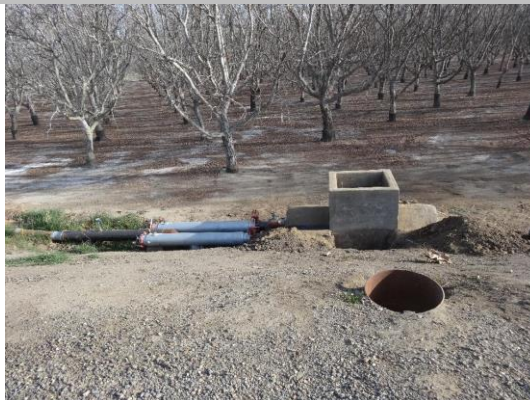
Photo 3 of 3 : UCIP\_FA\_2018\_50199\_53207.jpg

Comment Code						
Inspector Comment						
FS_ID:50199 DS_ID:20049 EP_NO: 8147 Repair Type: Non-Urgent Crossing Status: Found UCIP Comments: 08/29/2016: New pumps installed at LS toe ditch, could not find permit for this work. No signs of leakage or excessive vegetation growth in alignment with the pipe. Riser silted in; recommend installing a lid. Crossing has been downgraded from Urgent to Non-Urgent. (K. Fazel - UCIP)01/10/2014:Not found- slide gate in 48-inch corrugated metal riser at waterside toe.Repair works under way. Contact LMA for repair works information.Sign of leaky pipe and siphon breaker. This needs detailed investigation. (P. Amatya - DWR) FIELD_STRUCT_DESC: 12-inch steel irrigation discharge pipe through the levee, 4.8 feet below the crown. Slant pump mounted on a steel structure at the riverbank. 4-foot by 4-foot concrete distribution box at the landside (LS) toe with newly installed pumps with shutoff valves. (Replacement of a discharge pipe through the levee with a new 12-inch steel discharge pipe authorized under Permit No. 8147, 1972 - J. A. Driver). [Additional Reference(s): DWR Levee Log, 2005. USACE Sacramento O&M Manual 128, March 1960, (HLM 7.79)]. FS Date: 8/29/2016

LS view: steel riser with siphon breaker (bottom) and concrete distribution box on levee toe (top).

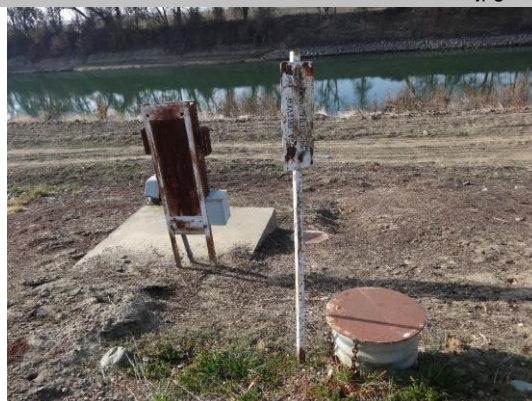
Photo 1 of 3 : UCIP\_FA\_2018\_28323\_52125.jpg

WS view: CMP with air vent (right), concrete pad (left), and switch panel (left) on levee slope.

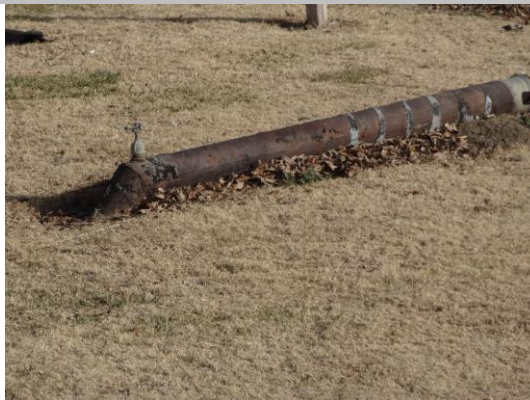
Photo 3 of 3 : UCIP\_FA\_2018\_28323\_52123.jpg

LS view: outlet steel pipe across the residential road off the levee toe on field.

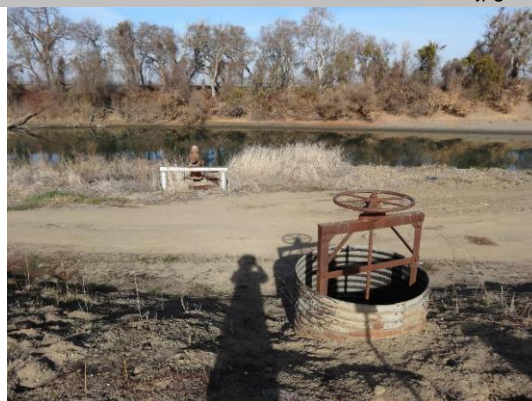
Photo 1 of 3 : UCIP\_FA\_2018\_28324\_52131.jpg

Comment Code						
Inspector Comment						
FS_ID:28324 DS_ID:20053 EP_NO: 10064 Repair Type: Non-Urgent Crossing Status: Found UCIP Comments: Looks abandoned as service pole not found.May need proper abandonment. FIELD_STRUCT_DESC: 24-inch by 24-inch concrete box irrigation discharge culvert through the levee, 13 feet below the crown. Two concrete cutoff walls. Pump on a 6-foot-diameter concrete pump well on the berm. Slide gate in a 42-inch corrugated metal pipe (CMP) riser on the waterside (WS) slope. 4.5-foot by 6-foot concrete distribution box at the landside (LS) toe. Installed by Reclamation District No. 1500 in 1920. Improvements made by USACE in 1955. (24-inch by 24-inch concrete box irrigation discharge culvert through the levee and all other appurtenances retained under Automatic Board Order (ABO) issued as Permit No. 10064, 1974 - Paul Donald Nix). [Additional Reference(s): DWR Levee Log, 2005. USACE Sacramento O&M Manual 128, March 1960, (HLM 8.44), 36-inch pipe referenced]. FS Date: 1/10/2014

WS view: slide gate in CMP riser on levee slope. Looks abandoned.

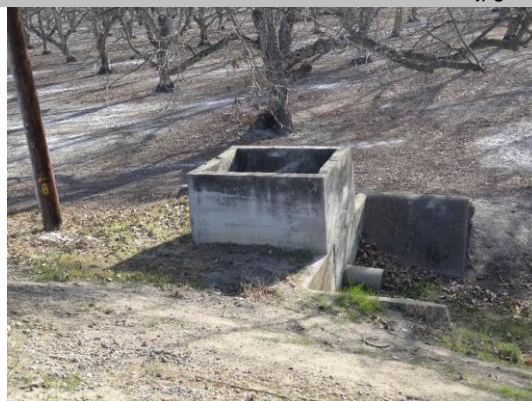
Photo 3 of 3 : UCIP\_FA\_2018\_28324\_52129.jpg

LS view: concrete distribution box on levee toe.

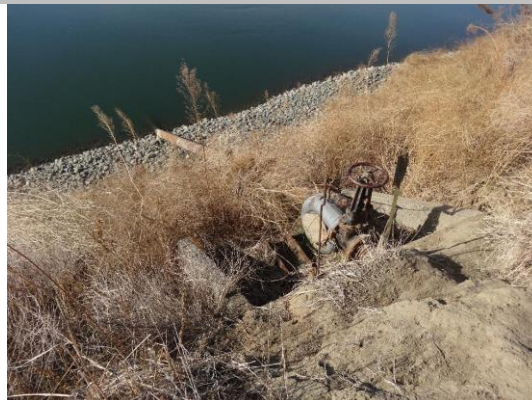
Photo 1 of 3 : UCIP\_FA\_2018\_28343\_52145.jpg

WS view: U type concrete headwall, pipe, and pump on river bank.

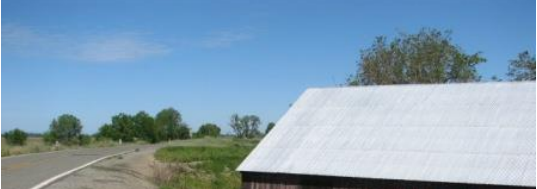
Photo 1 of 1 : FA\_2018\_RD1500\_189\_18\_20180904\_00008.jpg

The corner of the building has encroached into the toe.

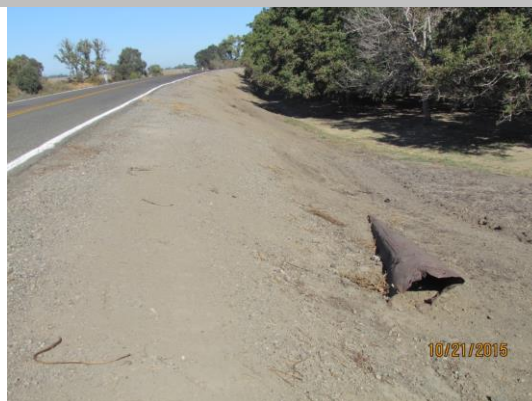
Photo 1 of 1 : FA\_2018\_RD1500\_189\_109\_20180904\_00046.jpg

LM Start	8.79	Rating **	M	Issue No.	109
LM End	8.79	Issue Type +	En	Location *	LS
Category	Earthen Levee			GPS Latitude/Longitude	
				Start	End
Item	Encroachments			38.843481 °	38.843481 °
				-121.727256 °	-121.727256 °
DWR ID	DWR_RD1500_01_f_2017_109				
Comment Code					
DE : Debris					
Inspector Comment					
Abandoned pipe is embedded into levee slope.

View of the abandoned pipe on the landward side of the levee looking upstream. Fall 2015.

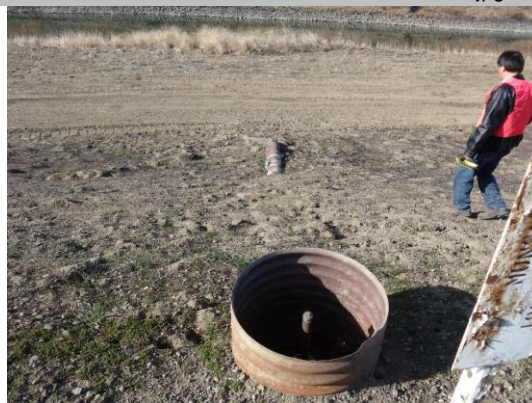
Photo 1 of 3 : UCIP\_FA\_2018\_28363\_52167.jpg

Comment Code					
Inspector Comment					
FS_ID:28363 DS_ID:20055 EP_NO: 8503 Repair Type: Non-Urgent Crossing Status: Found UCIP Comments: Looks abandoned. No pump found on WS.New well near landside.May need proper abandonment.Exposed pipe on waterside. Found steel plate closed pipe on landside. FIELD_STRUCT_DESC: *ABANDONED* 12-inch steel irrigation discharge pipe through the levee, 3.8 feet below the crown. Pump on concrete pad with headwall at the riverbank. Siphon breaker in a 24-inch corrugated metal pipe (CMP) riser on the waterside (WS) slope. 1.25-inch conduit through the levee, 3 feet below the crown. Meter pole with switch panel at the landside (LS) toe. Concrete distribution box at the LS toe. (12-inch steel irrigation discharge pipe through the levee and slant pump retained under Permit No. 8503, 1972 - James T. Munson). [Additional Reference(s): DWR Levee Log, 2005. USACE Sacramento O&M Manual 128, March 1960, (HLM 9.04), 10-inch pipe referenced]. FS Date: 1/10/2014

WS view: siphon breaker in CMP riser on levee slope.

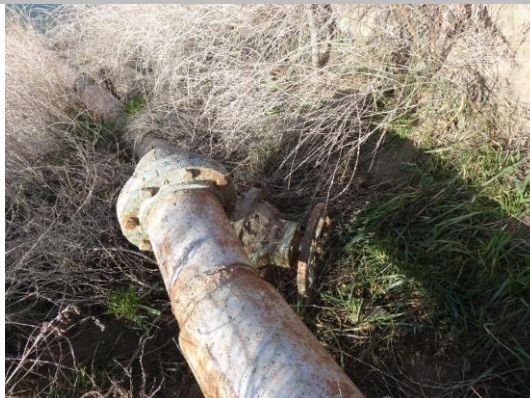
Photo 2 of 3 : UCIP\_FA\_2018\_28363\_52166.jpg

WS view: inlet steel pipe with gate valve on river bank.

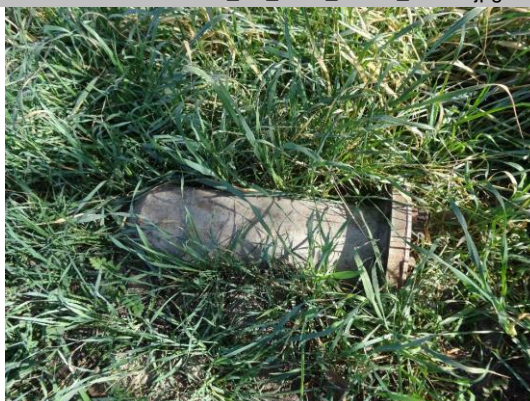
Photo 3 of 3 : UCIP\_FA\_2018\_28363\_52165.jpg

LS view: pipe end capped with steel plate on levee toe. Looks abandoned.

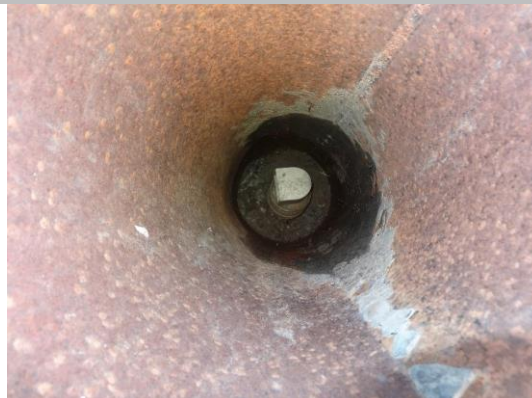
Photo 2 of 3 : UCIP\_FA\_2018\_28364\_52175.jpg

LS view: air vent in steel pipe riser on levee slope.

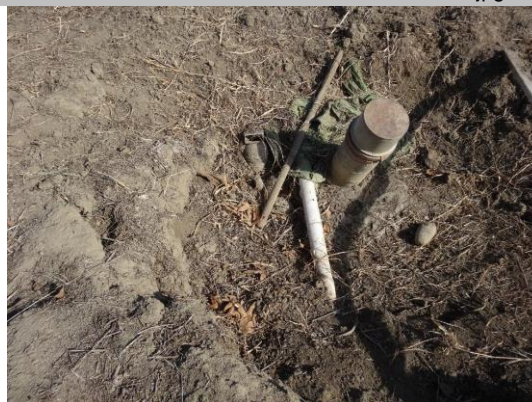
Photo 3 of 3 : UCIP\_FA\_2018\_28364\_52173.jpg

Not found- Flap gate on landward side.No outlet structure found. Only a capped pipe found, but not sure whether it is connected to the crossing.

LS view: capped outlet pipe on levee toe.

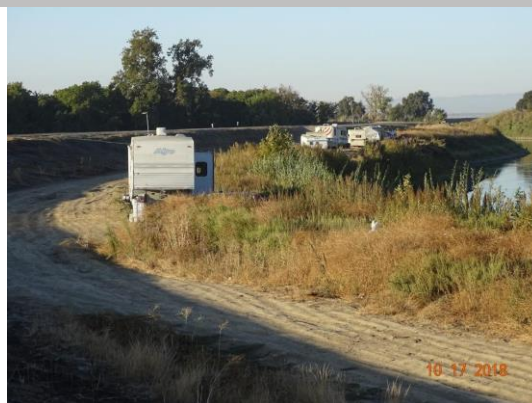
Photo 1 of 1 : FA\_2018\_RD1500\_189\_132\_20181018\_00234.jpg

LM Start	9.26	Rating **	U	Issue No.	132
LM End	9.42	Issue Type +	En	Location *	WS
Category	Earthen Levee			GPS Latitude/Longitude	
				Start	End
Item	Encroachments			38.849032 °	38.850566 °
				-121.725126 °	-121.723062 °
DWR ID	DWR_RD1500_01_f_2018_132				
Comment Code					
UR : Urban					
Inspector Comment					
Multiple trailers and constructed shacks on the waterside berm taking up long-term residence.

View of trailers and shacks on the waterside berm. Fall 2018.

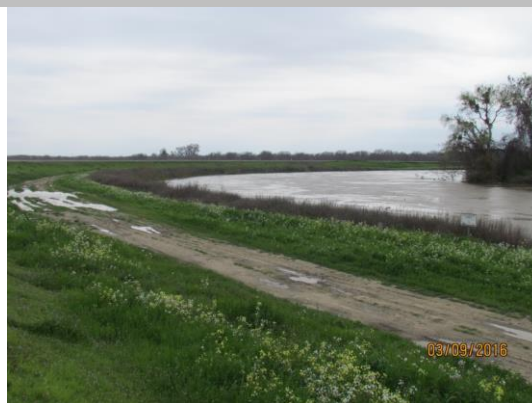
Photo 1 of 2 : FA\_2018\_RD1500\_189\_74\_20180904\_00030.jpg

LM Start	9.40	Rating **	A/W	Issue No.	74
LM End	9.57	Issue Type +	Ma	Location *	WS
Category	Earthen Levee			GPS Latitude/Longitude	
				Start	End
Item	Vegetation			38.850267 °	38.852564 °
				-121.723275 °	-121.723179 °
DWR ID	DWR_RD1500_01_s_2012_74				
Comment Code					
V8 : Environmental Requirements.					
Inspector Comment

View of the revegetation site along the edge of the berm on the waterward side of the levee looking downstream. Spring 2016.

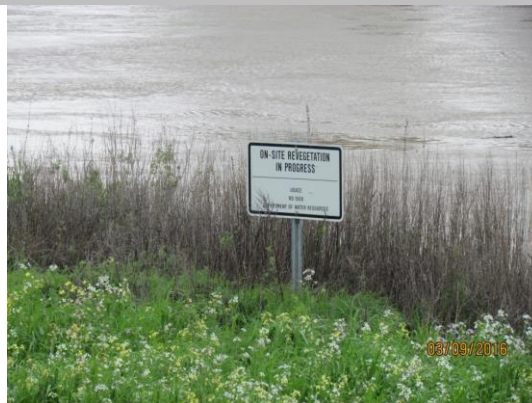
Photo 2 of 2 : FA\_2018\_RD1500\_189\_74\_20180904\_00031.jpg

Sign for the revegetation site by USACE.

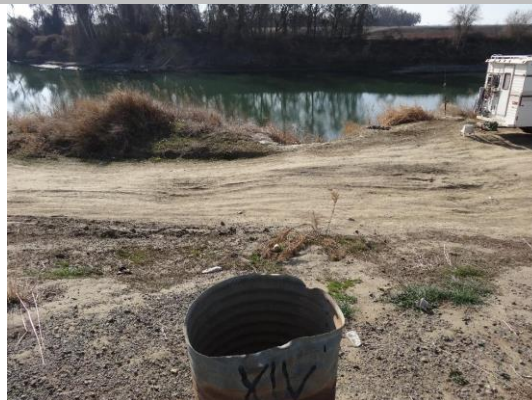
Photo 1 of 3 : UCIP\_FA\_2018\_28365\_52182.jpg

Comment Code						
Inspector Comment						
FS_ID:28365 DS_ID:20057 EP_NO: N/A Repair Type: Non-Urgent Crossing Status: Found UCIP Comments: Looks abandoned. Pump has been removed. No outlet pipe found. Not found- Wooden service panel and 3x5 foot concrete distribution box at landward shoulder.May need proper abandonment. FIELD_STRUCT_DESC: 14-inch steel irrigation discharge pipe through the levee, 4.2 feet below the crown. Pump and gate valve on a concrete pump platform on the bank. Siphon breaker in a 24-inch corrugated metal pipe (CMP) riser on the waterside (WS) shoulder. Wooden switch panel and pole on the WS slope. 3-foot by 5-foot concrete distribution box at the landside (LS) toe. (14-inch steel irrigation discharge pipe through the levee, pump, and all other appurtenances retained under Automatic Board Order (ABO) issued as Permit No. 10069, 1974 - Robert Reel). [Additional Reference(s): DWR Levee Log, 2005. USACE Sacramento O&M Manual 128, March 1960, (HLM 9.77)]. FS Date: 1/10/2014

WS view: CMP riser with siphon breaker on levee slope.

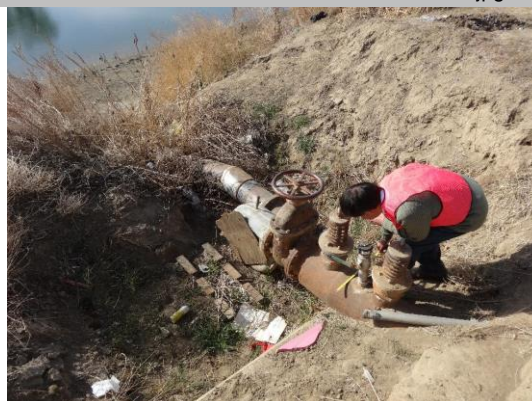
Photo 3 of 3 : UCIP\_FA\_2018\_28365\_52179.jpg

Comment Code						
Inspector Comment						
FS_ID:28365 DS_ID:20057 EP_NO: N/A Repair Type: Non-Urgent Crossing Status: Found UCIP Comments: Looks abandoned. Pump has been removed. No outlet pipe found. Not found- Wooden service panel and 3x5 foot concrete distribution box at landward shoulder.May need proper abandonment. FIELD_STRUCT_DESC: 14-inch steel irrigation discharge pipe through the levee, 4.2 feet below the crown. Pump and gate valve on a concrete pump platform on the bank. Siphon breaker in a 24-inch corrugated metal pipe (CMP) riser on the waterside (WS) shoulder. Wooden switch panel and pole on the WS slope. 3-foot by 5-foot concrete distribution box at the landside (LS) toe. (14-inch steel irrigation discharge pipe through the levee, pump, and all other appurtenances retained under Automatic Board Order (ABO) issued as Permit No. 10069, 1974 - Robert Reel). [Additional Reference(s): DWR Levee Log, 2005. USACE Sacramento O&M Manual 128, March 1960, (HLM 9.77)]. FS Date: 1/10/2014

LS view: U type concrete headwall, pipe, gate valve, and pump (removed and plugged with plywood) on river bank.

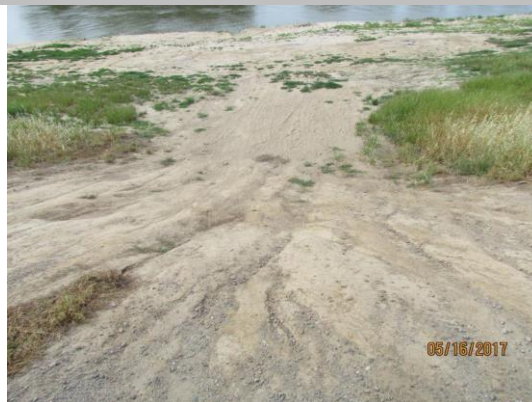
Photo 1 of 1 : FA\_2018\_RD1500\_189\_162\_20180904\_00076.jpg

LM Start	9.71	Rating **	A/W	Issue No.	162
LM End	9.71	Issue Type +	Ma	Location *	WS
Category	Earthen Levee			GPS Latitude/Longitude	
				Start	End
Item	Slope Stability			38.853564 °	38.853564 °
				-121.725379 °	-121.725379 °
DWR ID	DWR_RD1500_01_s_2017_162				
Comment Code					
S3 : Repair the levee slope damaged by vehicle traffic and prevent access where possible.					
Inspector Comment					
Area heavily accessed by trailer residents and fishermen. Recommend monitoring.

View of slope stability on waterside slope. Spring 2017.

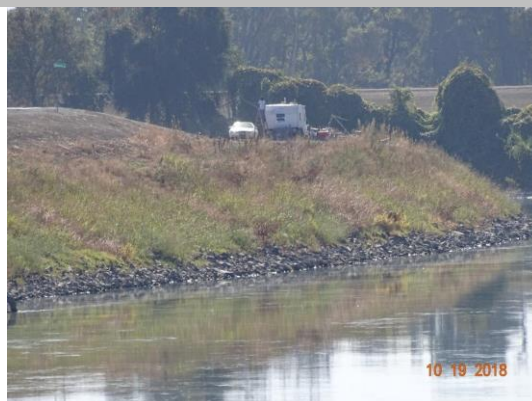
Photo 1 of 1 : FA\_2018\_RD1500\_189\_130\_20181018\_00235.jpg

LM Start	9.85	Rating **	U	Issue No.	130
LM End	9.85	Issue Type +	En	Location *	WS
Category	Earthen Levee			GPS Latitude/Longitude	
				Start	End
Item	Encroachments			38.853986 °	38.853986 °
				-121.727838 °	-121.727838 °
DWR ID	DWR_RD1500_01_f_2018_130				
Comment Code					
UR : Urban					
Inspector Comment					
Trailer parked on the waterside berm taking up long-term residence.

View of the trailer and debris on the waterside berm. Fall 2018.

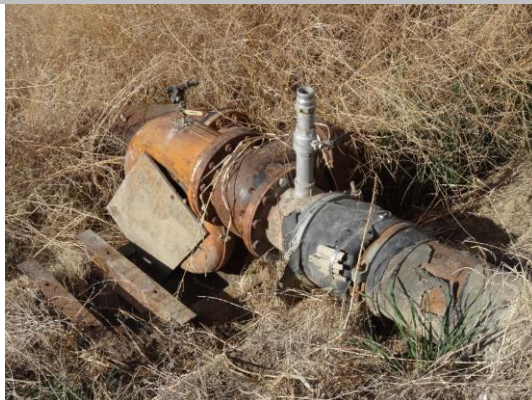
Photo 1 of 3 : UCIP\_FA\_2018\_50069\_52188.jpg

FS\_ID:50069  
DS\_ID:20058  
EP\_NO: 10068  
Repair Type: Non-Urgent  
Crossing Status: Found  
UCIP Comments: 01/10/2014 Surface erosion along pipe alignment on landside. 30-inch concrete pipe in CMP riser on waterside. 30-inch x 24-inch concrete culvert on landside.  
FIELD\_STRUCT\_DESC: 24-inch by 30-inch reinforced concrete box irrigation discharge culvert diagonally through the levee, 13 feet below the crown. Two concrete cutoff walls. Slant pump on the riverbank. Slide gate in a 40-inch by 40-inch concrete surge box on the berm. Power pole and switch panel on the waterside (WS) slope. Concrete distribution box at the landside (LS) toe. Installed by Reclamation District No. 1500 in 1920. (24-inch by 30-inch reinforced concrete box irrigation discharge culvert diagonally through the levee, slant pump, and all other appurtenances retained under Automatic Board Order (ABO) issued as Permit No. 10068, 1974 - Cecil Reel). [Additional Reference(s): DWR Levee Log, 2005. USACE Sacramento O&M Manual 128, March 1960, (HLM 10.22)].

WS view: pipe and pump with appurtenances on river bank. Pump removed and plugged with plywood.

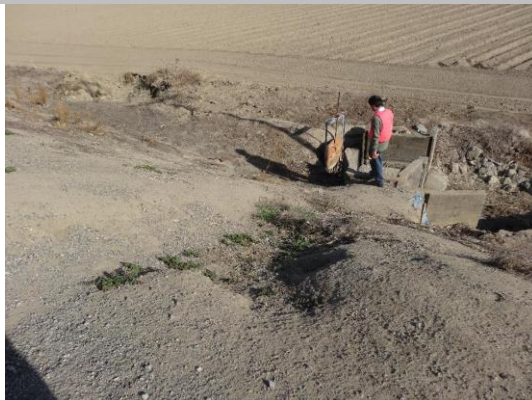
Photo 2 of 3 : UCIP\_FA\_2018\_50069\_52189.jpg

LS view: surface erosion along pipe alignment on landside.

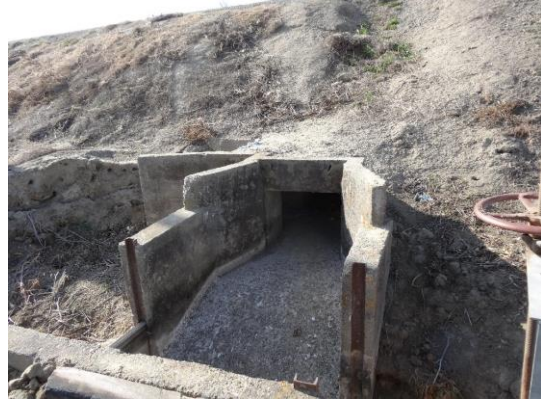
Photo 3 of 3 : UCIP\_FA\_2018\_50069\_52192.jpg

LS view: outlet of concrete box culvert on levee toe.

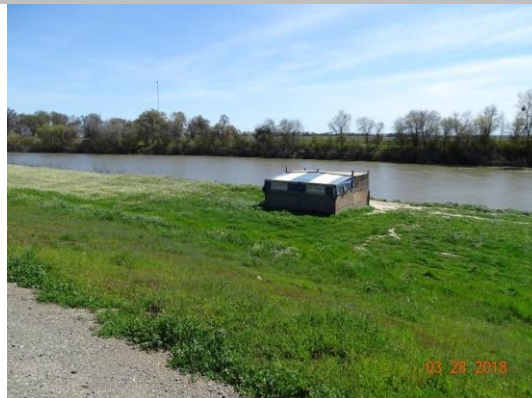
Photo 1 of 1 : FA\_2018\_RD1500\_189\_124\_20180904\_00061.jpg

LM Start	10.61	Rating **	U	Issue No.	124
LM End	10.61	Issue Type +	En	Location *	WS
Category	Earthen Levee			GPS Latitude/Longitude	
				Start	End
Item	Encroachments			38.861171 °	38.861171 °
				-121.735337 °	-121.735337 °
DWR ID	DWR_RD1500_01_s_2018_124				
Comment Code					
BU : Building					
Inspector Comment					
Residence built on the waterside berm.

View of shack on waterside berm. Spring 2018.
